Performance Standard for Protective Coating

Waterballast tanken

Bureau Veritas Netherlands

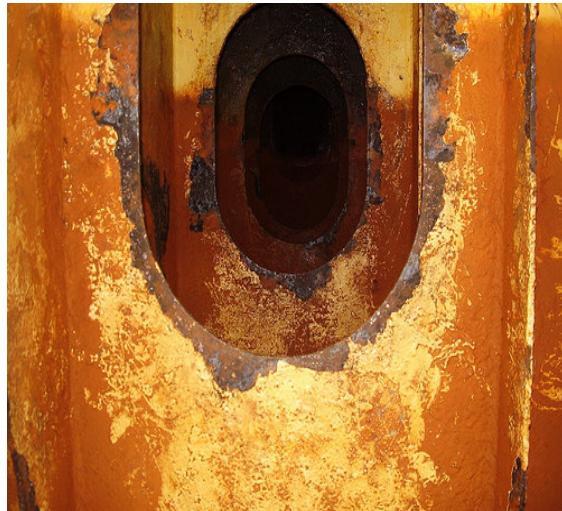
Coating that will last for minimum 15 years

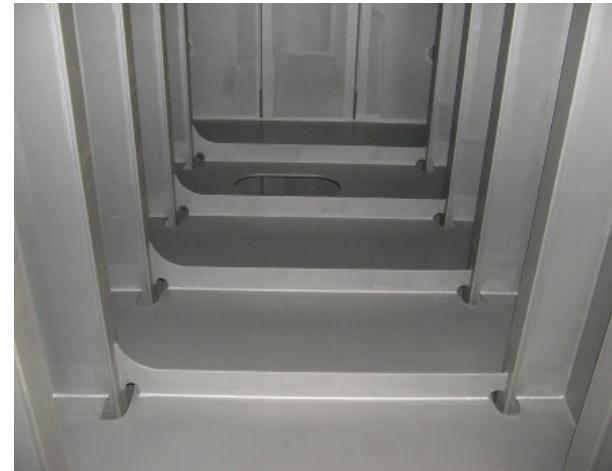
POOR

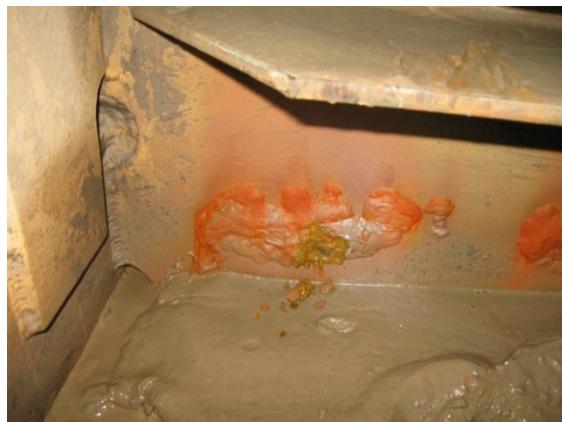
NEW

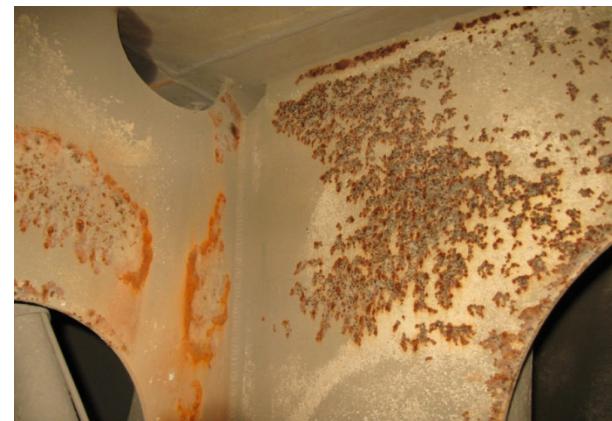
GOOD

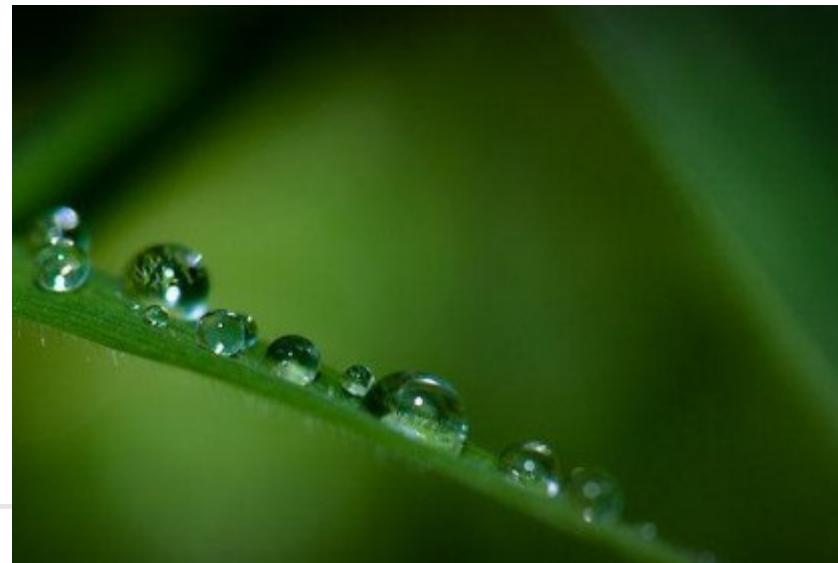
Dauwpunt bij gelijkblijvende dampdruk treedt condensatie op.

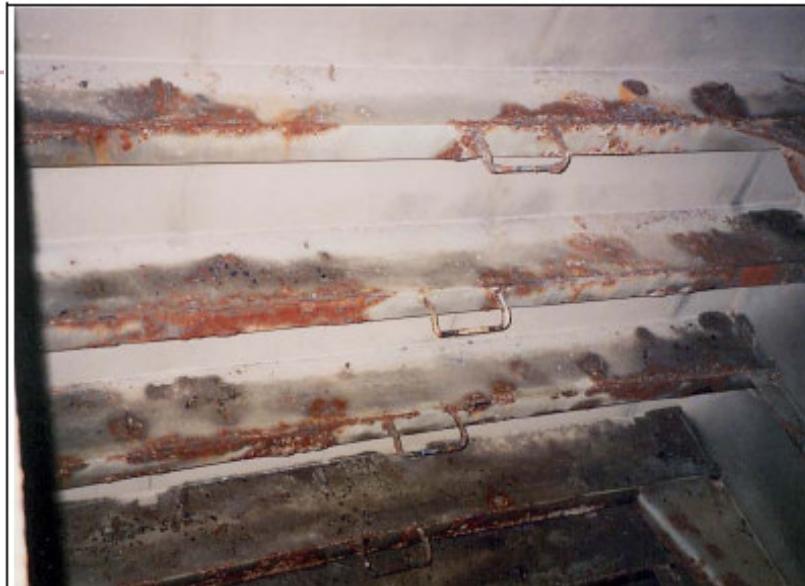
► Coating “Fair”

Notes: Condition: FAIR

Breakdown of coating/area rusted: localised 15-20%

Area of hard rust scale: Less than 10% of the area rusted

Local breakdown of coating or rust on edges or weld lines: 30-40%

Remarks: FAIR for longitudinal close to bottom, remaining surface; GOOD

- ▶ good: condition with only minor spot rusting
- ▶ fair: condition with local breakdown at edges of stiffeners and weld connections and/or light rusting over 20% or more of areas under consideration, but less than as defined for poor condition
- ▶ poor: condition with general breakdown of coating over 20% or more or hard scale at 10% or more, of areas under consideration

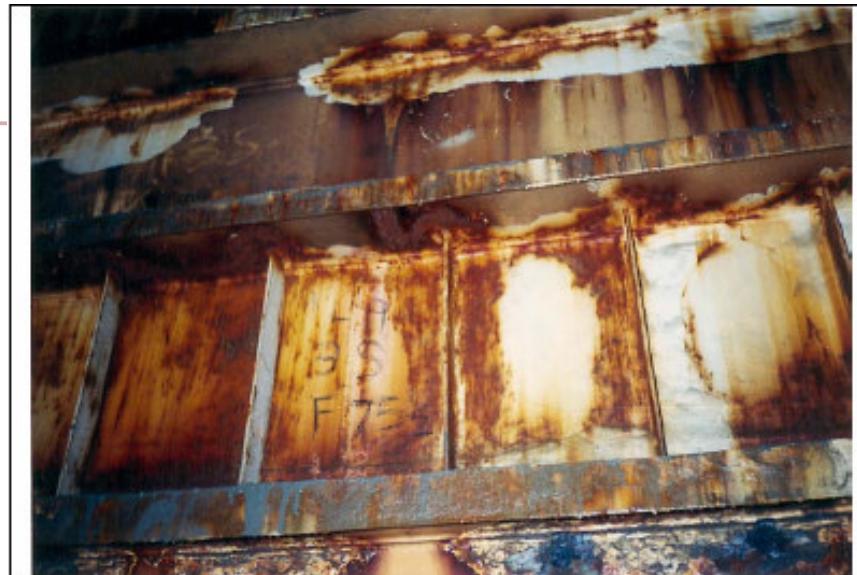
► Coating “Poor”

Notes: Condition: POOR

Breakdown of coating/area rusted: approx. 30%

Area of hard rust scale: More than 10% of the area rusted

Local breakdown of coating or rust on edges or weld lines: 30-40%
